## 5.5 Shielded Room Issues

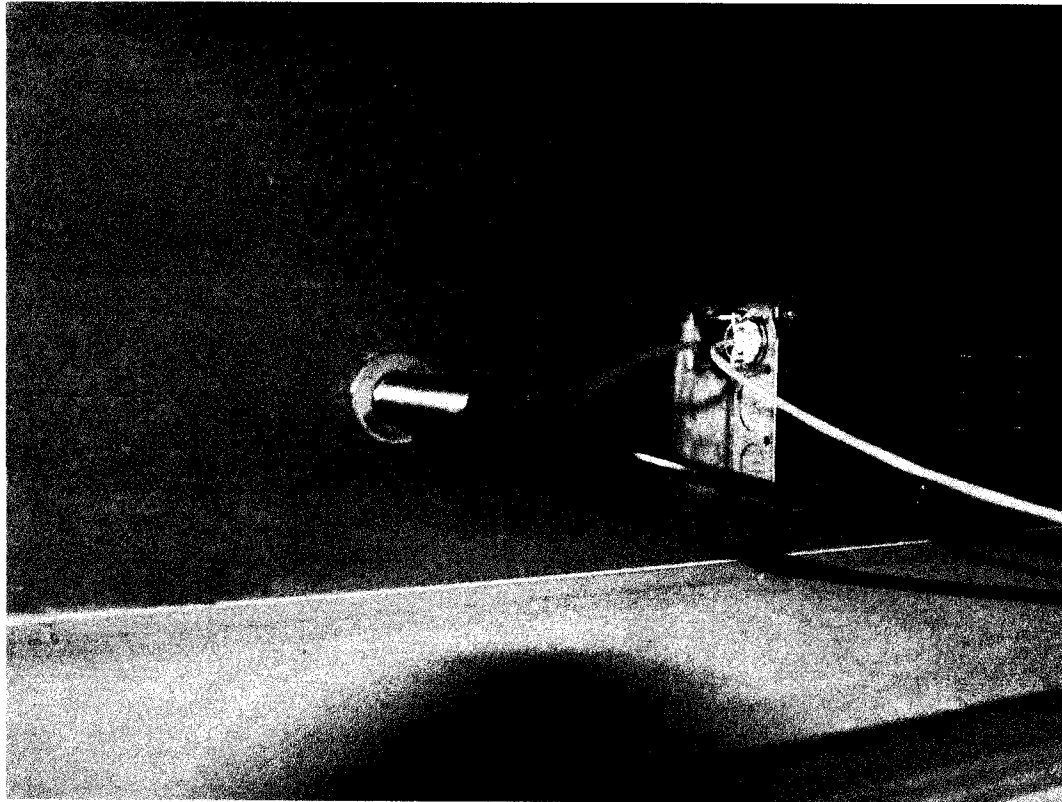
Figure 19 shows another penetration of a shielded room. In this case a coaxial cable associated with the site's security system penetrated the shielded room. Its shield carried EMI current and voltage into and out of the shielded room. This kind of conducting penetration must be avoided since a single such penetration as shown can completely destroy the effectiveness of a shielded room. In this case a standard coaxial bulkhead connector at the penetration point would have provided a satisfactory means of terminating the cable shield on both sides of the wall of the shielded room.

**Figure 19    Coaxial Cable Penetration of a Shielded Room**

Of interest is that other similar penetration tubes have been found that carry non-conducting fiber-optic cables into and out of shielded rooms. Such penetrations are acceptable since non-conducting cable can not conduct EMI current or voltage into or out of the room, however some fiber-optic cables are constructed with metallic armor, and these should be treated the same as the shield on coaxial cable.

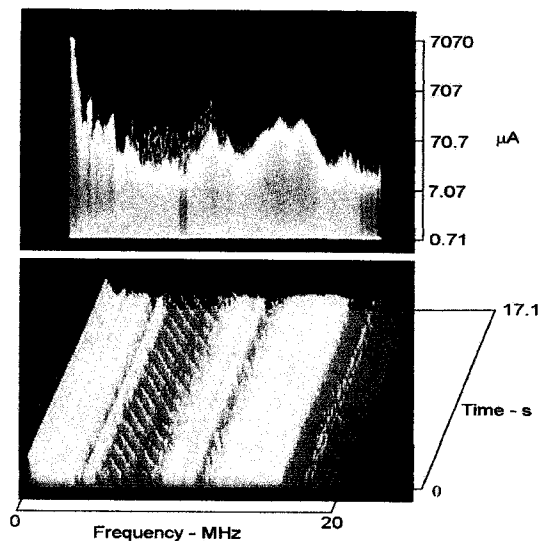
B, 9/10, 051021, 1419, 10, 20, 10, 200, F-70, NF, 20, 0, -30  
PDU, Blue Cable

A few examples of excessive EMI current flowing on cables in a receiving site will demonstrate the problem. Figure 21 shows EMI current flowing on one of the 3-phase output power conductors of a Power Distribution Unit (PDU) over the frequency range of 100 kHz up to 10 MHz. This particular PDU was located within a shielded room that housed the RF-distribution equipment for an HF receiving site. The PDU contained a switching power supply for its electronics along with other digital control devices, and it provided electric power to all equipment located within the shielded room.

Severe peaks and nulls in noise amplitude were found across the entire frequency range of the data at levels significantly above the minimum tolerable level provided in Table 1. The slanting lines in the time-history view over the frequency range of about 3.5 to 8 MHz are from repetitive impulsive noise with a period of 8.3 ms (a pulse occurrence rate of 120 per second). The amplitude of these impulses is shown in the upper amplitude-vs.-frequency view. The noise in the remaining part of the HF band was a combination of impulsive noise at lower levels and closely-spaced spectral components related to harmonics of the power-line frequency and of the switching rate of the power-converter device.

The PDU was examined to determine if it was procured in accordance with the FCC Class B noise voltage rating. No label was found on the unit, a violation of the FCC rules. While the voltage level of noise was not measured in accordance with the FCC test procedures, the high noise current level clearly indicate this unit was either manufactured to the FCC Class A industrial noise requirement or the noise requirement was simply ignored.

An examination of the power-conversion devices contributing to the harmful levels of radio noise in Figures 21, 22 and 23 did not reveal the expected Class B or Class A labels required by the FCC for such devices marketed for general sale. Additional examination and measurements indicated that all were intended for industrial use rather than meeting the FCC Class B requirement for residential use. The use of such devices in and near a radio receiving site can significantly degrade the ability of a site to receive low-level radio signals of special interest, and they should not be installed in such facilities.

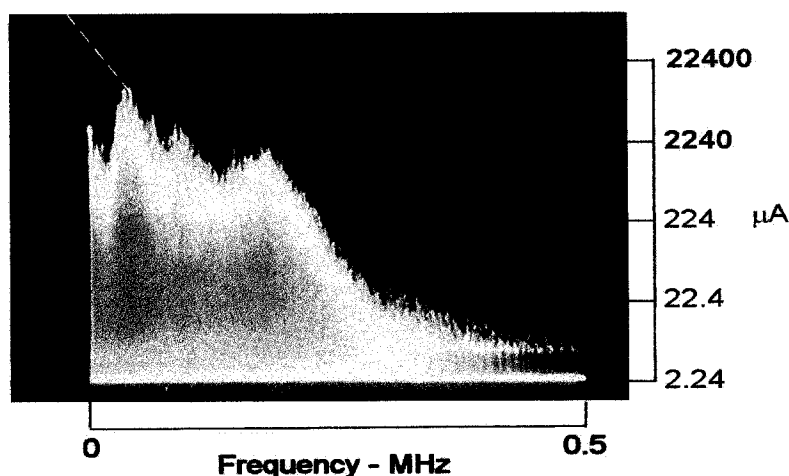
B, 7, 051023, 1145, 0.25, 0.5, 3, 100, F-70, NF, 20, 0, -20  
Blue Cable, UPS J Box in B

Figure 22 shows noise on one of the 3-phase conductors feeding power into the shielded room. In this case the power is provided to a 30-kVA UPS located in an adjacent shielded room, and it passed through a large low-pass filter located on the UPS side of the wall of the shield separating the two rooms. The drop in noise amplitude above about 200 kHz is caused by the filter. Note that the noise level at 500 kHz is very low, and the device met the requirements of Table 1 for a large site at all frequencies above about 1 MHz. The filter installation was effective at the higher frequencies, but excessive levels of noise and harmonic components of the power-line frequency and the switching rate of the UPS exceeded the low-frequency level stated in Table 1.

Figure 22 UPS Noise after a Filter

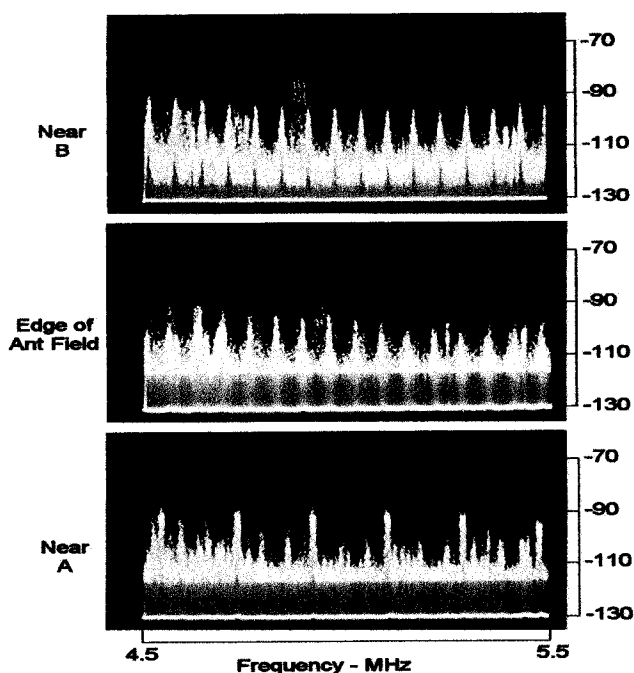
LZO, B/BA/A, 051027, 1253/1309/1330, 5, 1, 3, 100, Dipole-0, NF, 20, 0, -30  
Ambient from antenna on gnd at three locations

Figure 23 shows the amplitude of spectral components of noise collected by the test dipole antenna over the frequency range of 4.5 to 5.5 MHz at three locations. The top location was near the center of the antenna field, the middle location was near the edge of the antenna field, and the bottom location was near a nearby large facility. The data clearly show that excessive spectral components of noise were injected into the test antenna and also into the site's antenna counterpoise wires from EMI current flowing on the underground cables.

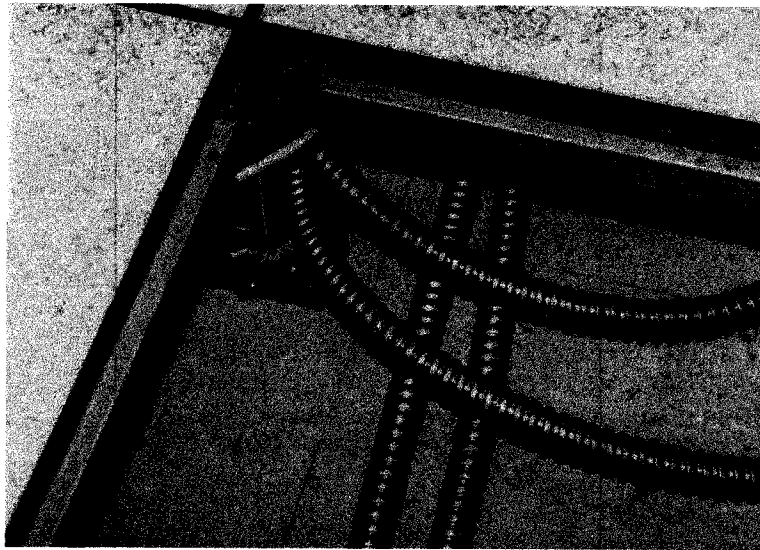
Figure 26 shows a photograph of unwanted intermittent contacts. MC cables providing power to electronic devices were in loose contact with each other. Also two of the cables were in intermittent contact with a metal floor stanchion. Unfortunately, the MC cable shields carried significant levels of current at harmonics of the electric power, and a person walking on the floor above can cause sufficient movement to produce harmful levels of transients.

**Figure 26** Incidental Contact, Example 1

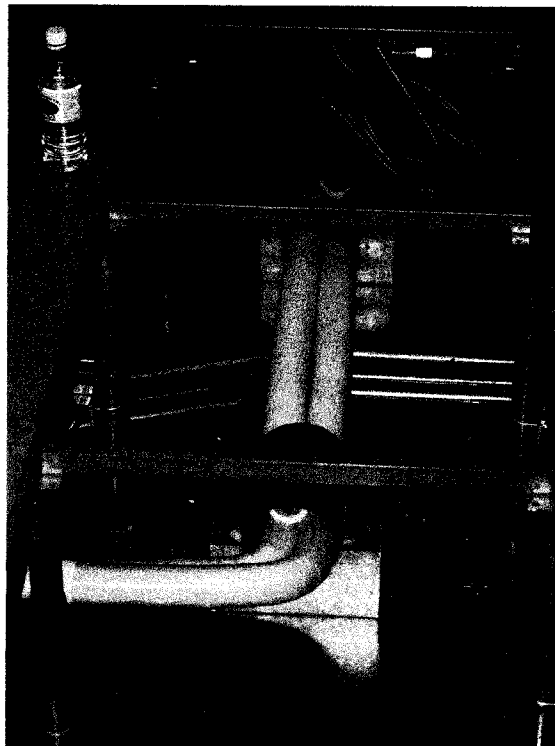
Still another example of incidental contacts between conductors is shown in Figure 27. In this case an extra length of MC cable was coiled and left under the floor in loose contact with other conductors. It also resulted in unwanted transients when anyone walked on the floor above the cable. Of interest is that the photograph shows that other metal objects were properly bonded together to avoid the production of transients.

**Figure 27** Incidental Contact, Example 2

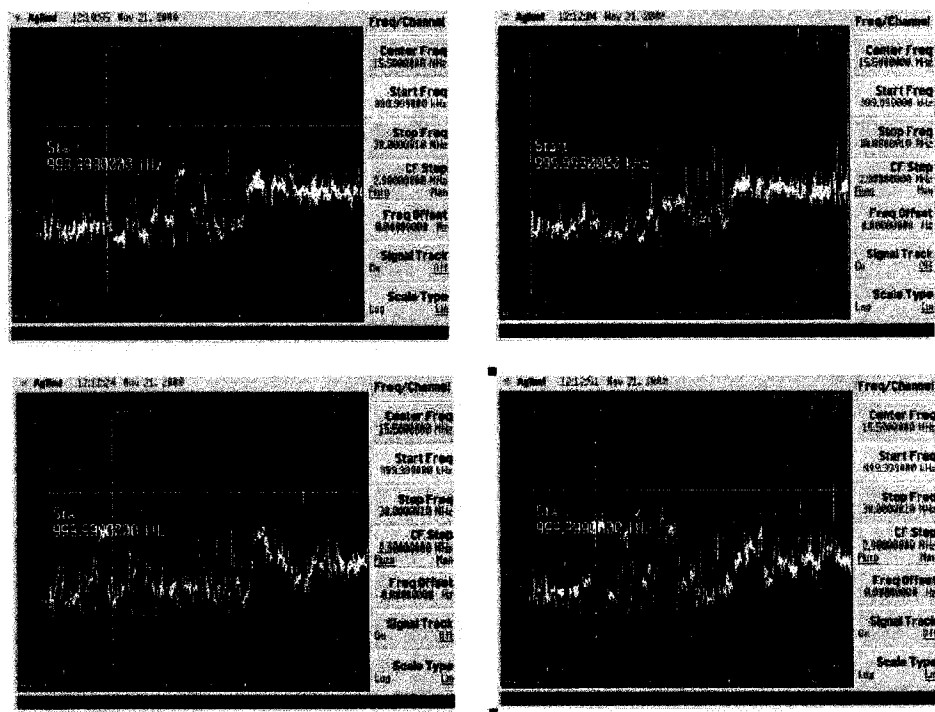
Figure 30 shows an example of erratic noise and interference found over the 1- to 20-MHz portion of the HF band at a receiving site where the data was obtained with a conventional scanning spectrum analyzer. Four sequential scans are shown where the spacing between the first two scans is about 20 seconds, and the spacing between the other examples is only a few seconds. A careful examination of the four examples shows significant differences in detail from one to the next one. The spectral and temporal properties of the noise and interference changed significantly from example to

example, and the changes cannot be understood from such sequential examples. These examples illustrate the difficulty in describing erratic noise and interference with standard instruments.

Figure 30 Example of Erratic Noise and Interference

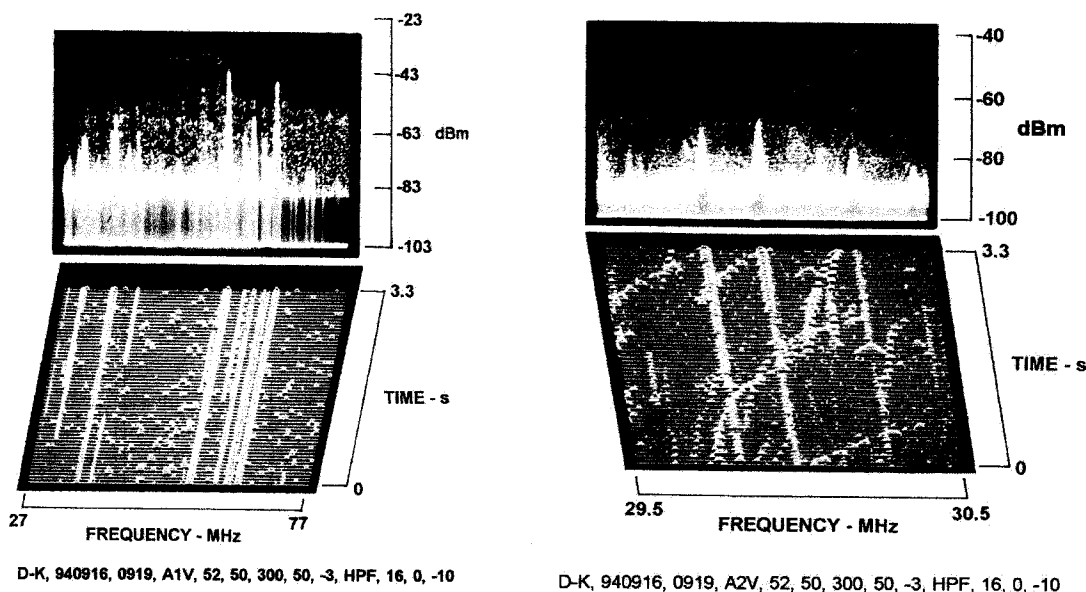
The right view shows variable-frequency emissions causing intermittent interference to an HF receiver. In this case, multiple emissions from the radio-frequency heaters of multiple plastic molding machines caused the intermittent interference. Such emissions are permitted for the Industrial, Scientific and Medical (ISM) radio service within the band of  $27.120 \text{ MHz} \pm 160 \text{ kHz}$ . The emissions originated from a factory located more than 10 km from the receiving site, and the emissions are clearly outside their allocated frequency band.

**Figure 32 Intermittent Interference from Frequency-Hopping and ISM Emissions**

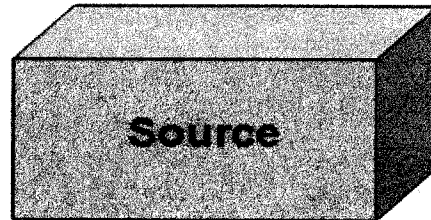
Figure 36 shows the basic aspects of the BFG process where a source is completely enclosed within an electromagnetic barrier. The barrier can be metal such as steel or aluminum. Special materials such as  $\mu$ metal are seldom required to achieve a sufficient level of control. The shield can have electrically small holes such as found in copper screen or punched aluminum material, and standard commercial metal boxes or cases often provide sufficient shielding. Expensive shielded rooms are only required for special cases or physically large systems.

**Figure 36** Source Enclosed within an Electromagnetic Barrier

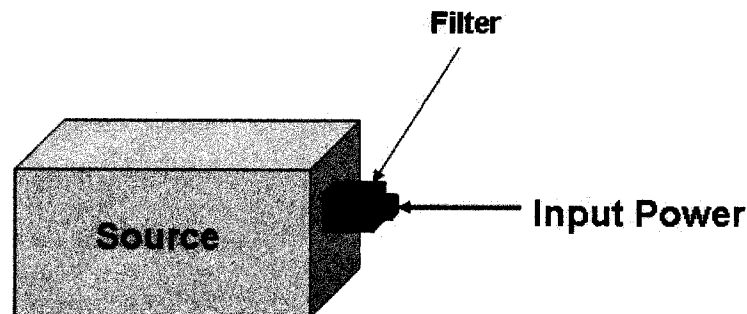
Figure 37 shows how power can be applied to a source. A bulkhead type of filter can be installed directly onto the metallic surface of an enclosure and alternating- or direct-current power can be provided to internal devices through the filter. The filter allows low-frequency electric power to be provided to the source at very low loss while higher-frequency noise is attenuated and cannot be conducted onto the outside power conductors at harmful levels. In addition, the filter prevents external interference and noise from penetrating into the shielded enclosure. Small and inexpensive filters can be used on low-power sources, but large filters will be required for high-power sources. The primary rule is that no conductor can be allowed to penetrate the electromagnetic shield without a filter or other means to prevent the flow of harmful levels of EMI current or voltage to leave or enter the enclosure.

**Figure 37** Provision of Power to a Source

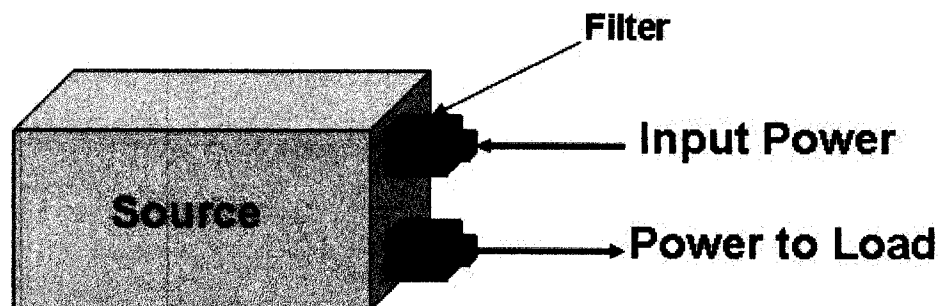
Most sources also must operate or be connected to an external device. For example, many power-conversion devices operate variable-speed induction electric motors by varying the frequency of the power provided to the motor. A second filter can be installed on the surface of the electromagnetic barrier to prevent the conduction of noise current and noise voltage onto conductors leading to external locations or the conduction of noise current and voltage from external sources from entering the enclosure as shown in Figure 38.

**Figure 38 Provision of Power to a Load**

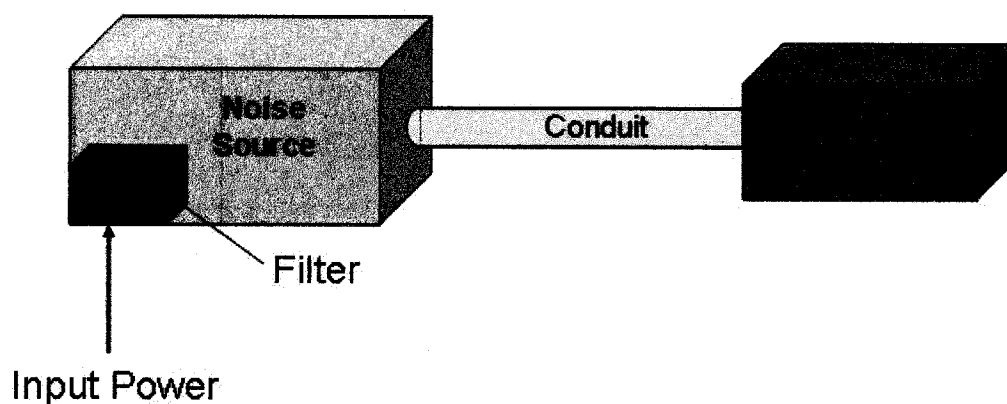
Alternatively, the electromagnetic barrier can be extended to include the conductors from the barrier to a load. For example, most electric motors are sufficiently enclosed in metal to provide a suitable electromagnetic barrier. Figure 39 shows such a configuration where metal conduit is used between the source and a motor or other load to shield the conductors. The conduit or shield around the conductors must be electrically bonded to both the source barrier and to the barrier enclosing the motor or other load. Open shields cannot be used.

**Figure 39 Source-to-Load Connection**

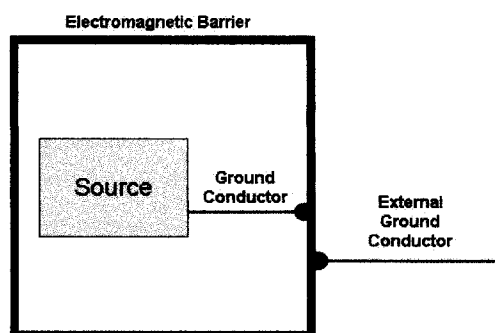
Most electrical and electronic installations require a safety or green-wire ground. Unfortunately, ground conductors often carry significant amounts of high-frequency noise current and voltage (often at higher levels than on the power conductors). Figure 40 shows an effective means to prevent the conduction of high-frequency noise current and voltage from an internal source to an outside conductor over a ground wire or from an external source into the barrier. Ground conductors inside the barrier are bonded to the inside surface of the barrier. Ground conductors outside the barrier are bonded to the outside surface of the barrier. This provides a path for noise current flowing on the internal ground conductor to return to its source inside the barrier. The barrier also prevents the conduction of high-frequency noise current and voltage from external sources into the barrier. Since the barrier will conduct low-frequency power-related current with little loss, all safety aspects of the NEC green-wire ground are maintained.

**Figure 40** Barrier Treatment of a Ground Conductor

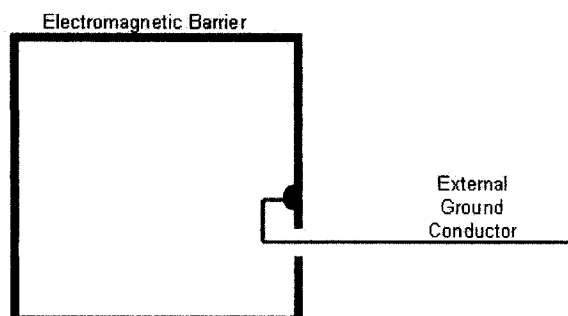
Figure 41 shows a ground configuration that meets the requirements of the NEC, but it violates BFG principles. In this case the green-wire ground is carried into the interior of the electromagnetic barrier through a hole, and noise and interference current will flow into and out of the barrier. This configuration should never be used for electronic devices in a radio-receiving site.

**Figure 41** Improper and Ineffective Treatment of a Ground Conductor

Unfortunately, the method of grounding shown in Figure 41 is frequently used in electronic equipment, and Figure 42 shows two views of a popular type of chassis power connector that fits this case. The ground conductor of the plastic connector protrudes inside a chassis barrier, and it connects to the inside surface of the barrier. The connector meets all requirements of the NEC green-wire ground, but it does not provide a means to control high-frequency noise current or voltage flowing on any conductor. This type of power connector can be used on devices or equipment that does not contain a source of EMI or on equipment that is not susceptible to EMI (such as an incandescent light bulb), but its use in electronic equipment should be strictly avoided.

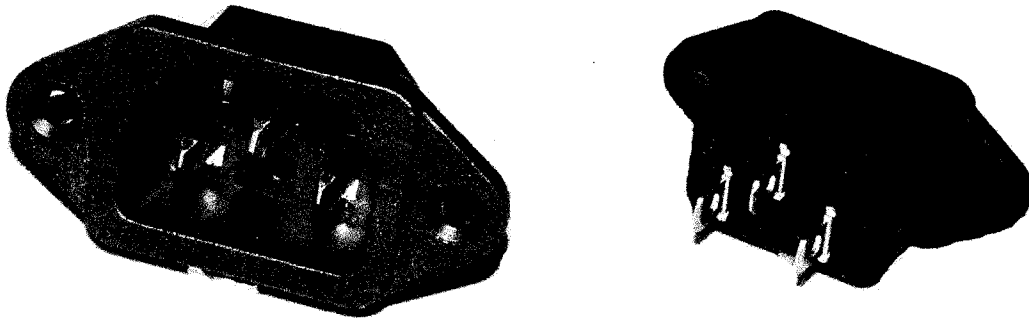
**Figure 42** Chassis Power Connector that does not comply with BFG Needs

Figure 51 shows a computer power supply with a type of power connector normally considered unacceptable (see Figure 42). However, the internal circuits of the switching power supply in this computer were designed to meet the low-noise emissions requirements of the Federal Communication Commission Class B noise specification, and a label on the computer indicated it had been tested to the Class B specification. In this specific case, the use of the unfiltered connector is acceptable.

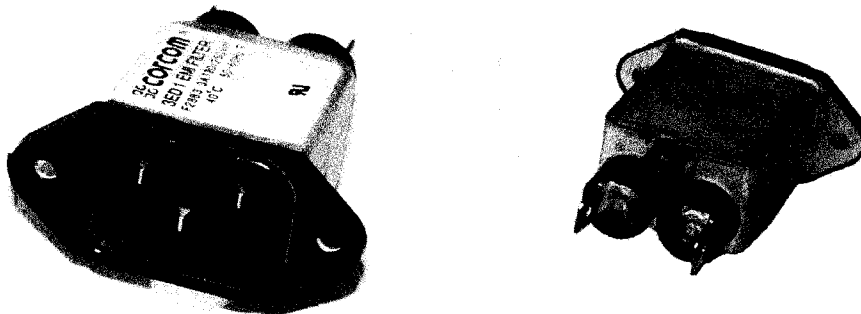
Figure 43 shows another popular type of chassis power connector that is available from a number of manufacturers. In this case the connector provides a filter for each power conductor and the ground configuration of the connector meets all BFG requirements. The external ground wire is connected to the external surface of an equipment case or chassis while the internal ground is connected to the internal surface of the equipment case or chassis. While the figure shows a low-power connector, this style is available in a variety of power ratings and filter configurations. It is recommended for use in all electrical and electronic equipment that contains a source of EMI or is susceptible to EMI.

**Figure 43** Chassis Power Connector that meets BFG Needs

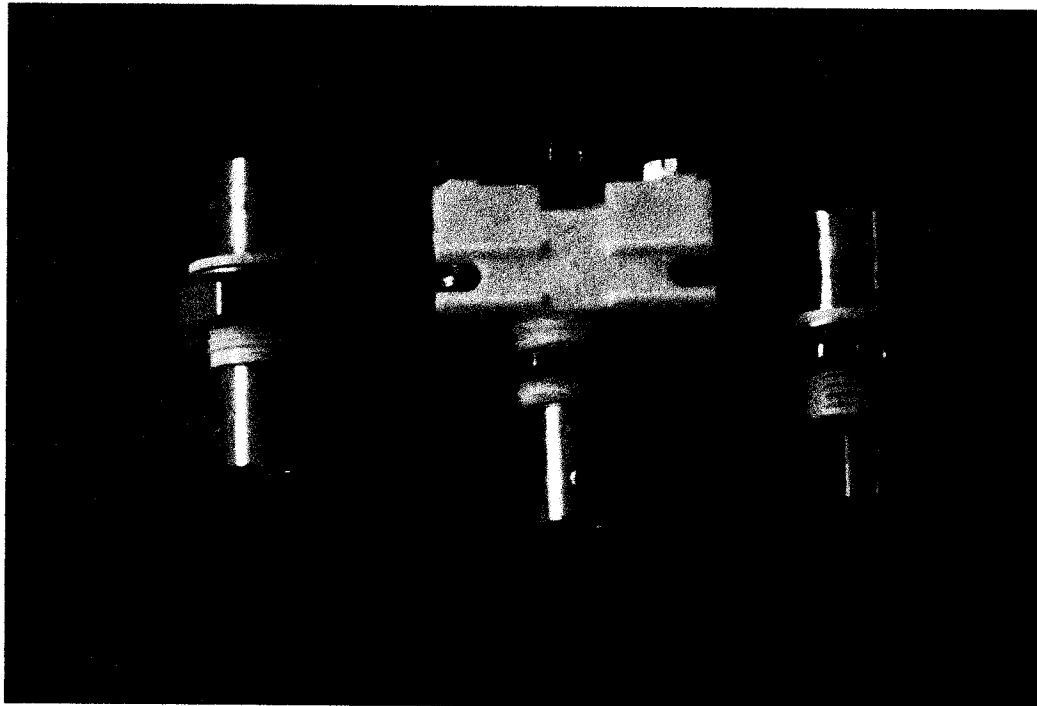
Many devices require additional conductors that penetrate an electromagnetic barrier. For example coaxial bulkhead fittings provide a means to interconnect coaxial cables between multiple barriers. However, one must use connector types that comply with the Barrier-Filter-Ground principles. Figure 44 shows three insulated bulkhead coaxial connectors that do not allow the coaxial cable shield to be terminated on each side of a barrier. The use of these types of insulated connectors must be avoided since they destroy the integrity of an electromagnetic barrier. EMI current from a source inside the barrier will be carried outside the barrier on the cable shield. Also, EMI current from outside sources will be carried to victim devices inside a barrier.

**Figure 44** Examples of Insulated Bulkhead Connectors

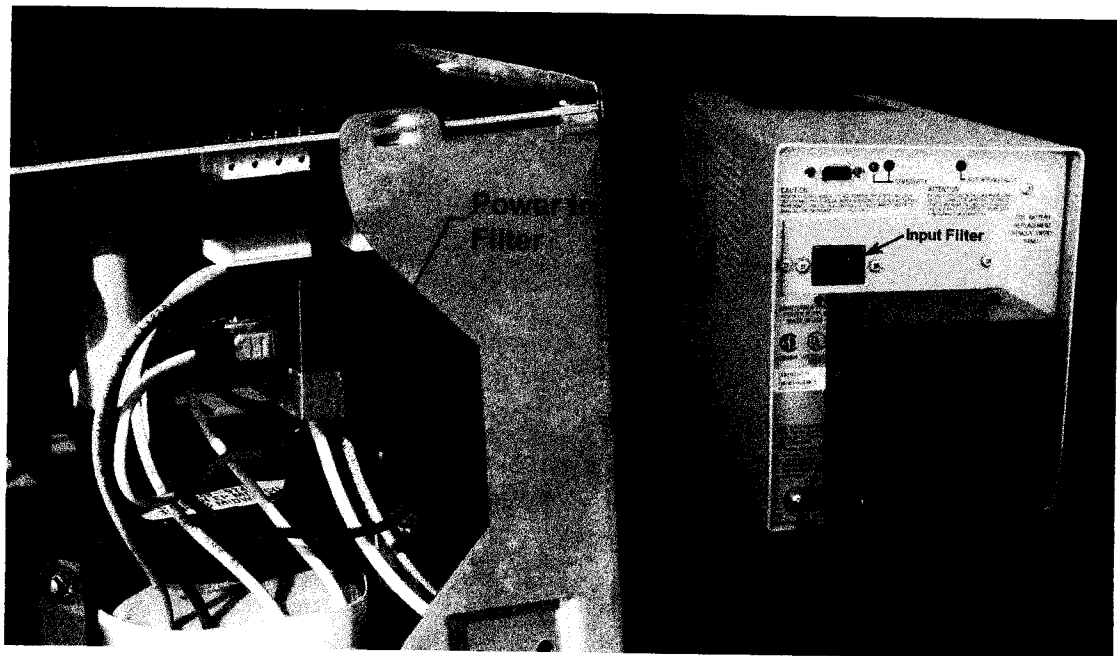
A filter for input 120-V power was added inside the case of the UPS as shown in the left view. There was not sufficient room inside the UPS for the output filter so it was added to the outside of the UPS case and was enclosed in a metal box to protect the short wires from the filter to the electrical sockets. The filter styles and their installation complied with the BFG principles, and the modification to the standard UPS successfully corrected a radio-noise problem.

**Figure 46**    UPS Modified to Comply with BFG Principles

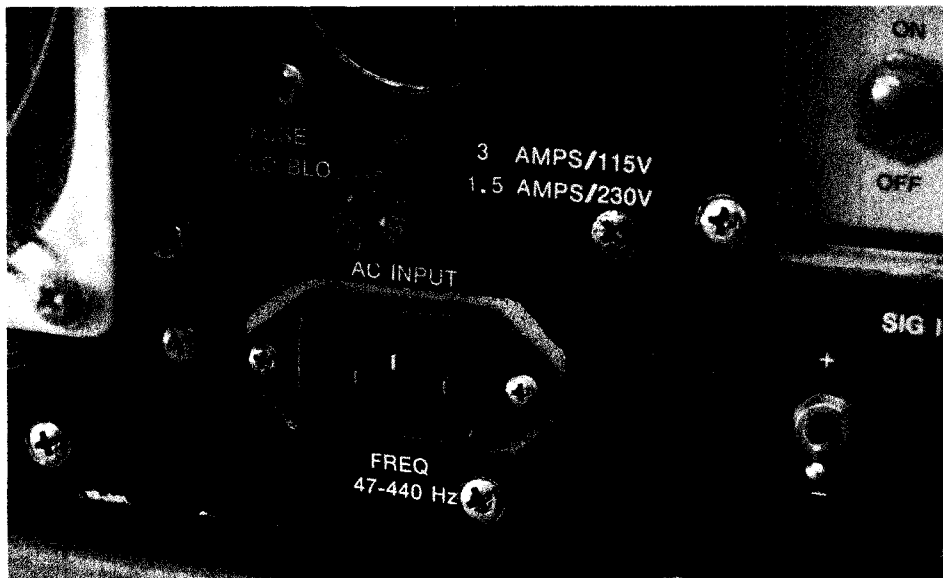
Figure 47 shows the rear panel of the Model 7200B Time-History Display described in Appendix A. This instrument contains high-level digital devices and switching power supplies that generate significant levels of impulsive noise, but its case was designed in accordance with the BFG principles described in this section. The power connector shown in the photograph is a small unit containing an integrated filter of the type described in Figure 43. The unit can be operated in close proximity to the antennas of a receiving site without producing detectable noise or interference.

**Figure 47 Power Connector that Complies with BFG Principles**

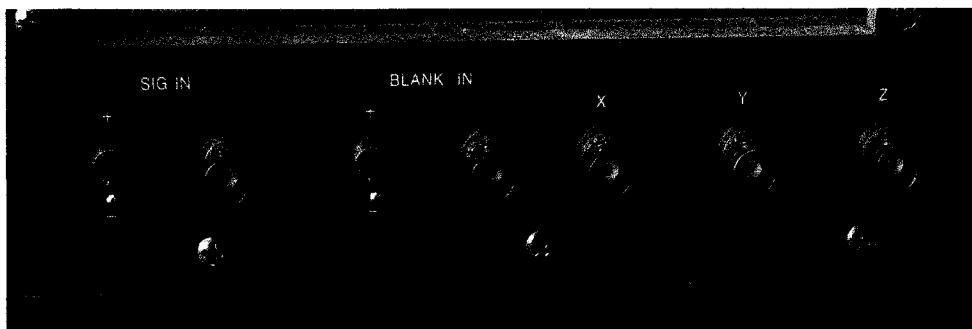
Figure 48 shows coaxial bulkhead fittings on the rear of the Model 7200B Time-History Display. Five bulkhead fittings were required to pass signals in and out of the unit. Non-insulated bulkhead connectors were used to terminate the shields of coaxial cables on both the inside and the outside of the instrument's case in accordance with BFG principles.

**Figure 48 Coax Feed Bulkhead Connectors that Comply with BFG Principles**

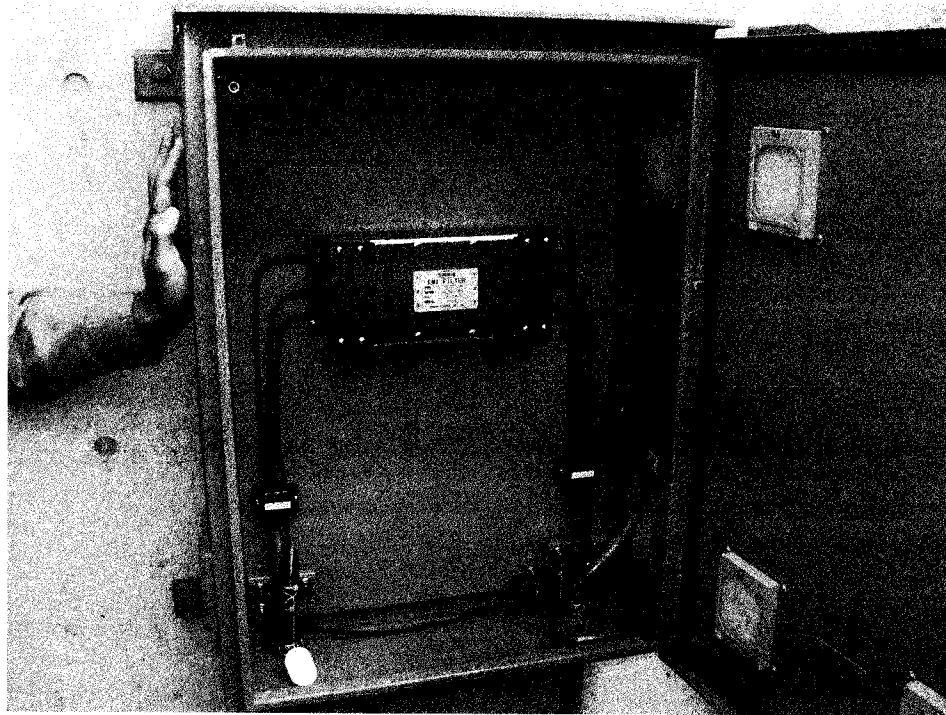
An example of an ineffective filter installation is provided to illustrate some common deficiencies that occur in improperly engineered attempts to solve electromagnetic-noise problems. Figure 49 shows a filter installed to prevent EMI current and voltage from a source from being received by nearby antennas. In this case the source was the electronic controller for a variable-speed fan motor of an air-conditioning unit. The physically-small electronic controller was located inside the large metal housing of the air-conditioner unit. Power to the air-conditioning unit and the variable-speed controller unit was provided through a metal conduit running to a filter located about 15 feet from the air-conditioner unit. Conduit then ran from the filter enclosure to the power panel.

The controller-to-filter conduit was properly terminated on the bottom left side of the filter box. The conduit to the power panel was terminated at the bottom right side of the filter enclosure. The filter was nicely installed in the standard metal housing that provided an excellent and acceptable shield around the filter; however other aspects of the installation completely negated the effectiveness of the filter.

**Figure 49    Improper Filter Configuration**

Several improper aspects of the filter installation resulted in the total lack of suppression of a severe electromagnetic impulsive noise problem. These aspects were:

There is no simple corrective action that can be taken to alter or correct the deficiencies of the filter installation shown in Figure 49. The only viable corrective action was at the source itself. In this case the source device was very small and its enclosure could have been a small and inexpensive metal box along with appropriate filters for all conductors penetrating the small enclosure in accordance with the principles shown in Section 7. These inexpensive and effective mitigation actions required:

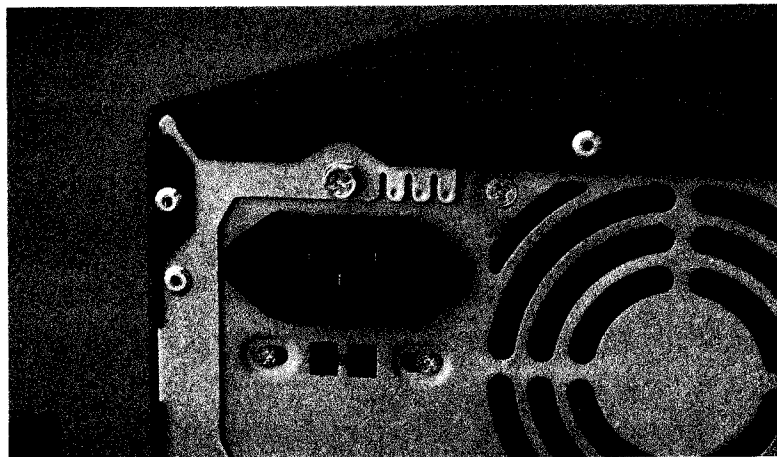
**Figure 51     Computer Power Supply not in Accordance with BFG Principles**

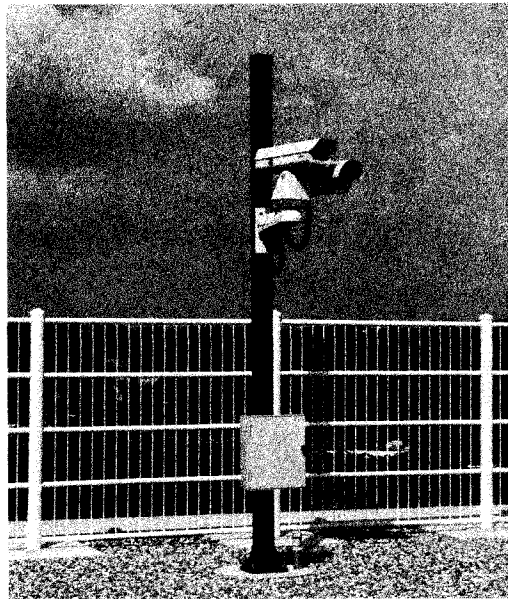
Figure 55 shows an example of a site issue that caused harmful levels of radio noise to appear at the input terminals of radio receivers. The security camera shown in the example was powered by a switching power supply that did not meet FCC Class B emission limits and was not modified in accordance with the barrier-filter techniques described in Section 7.1. Radiation from noise current flowing on the camera mount and its associated cables was intercepted by the nearby antennas. In this case the solution was to implement a field modification by replacing the switching power supply with an analog type of power supply.

**Figure 55** Security Camera Powered by a Noisy Switching Power Supply

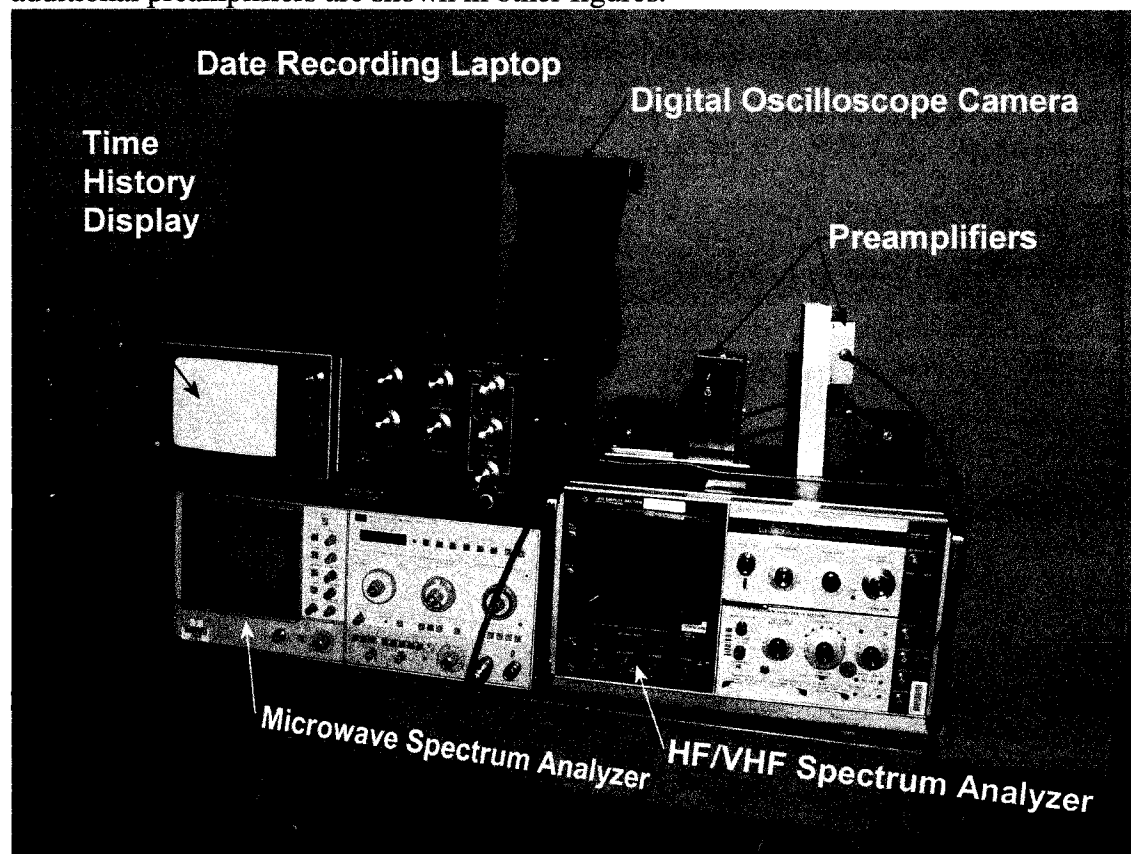
Figure 58 is a photograph of a typical instrumentation configuration used to investigate signals and noise appearing at the input of a receiver, signals carried on cable shields and ground conductors, or other uses. The instrumentation is mounted on a wheeled cart to allow moving it to any desired location, and only the primary instrumentation is shown. Auxiliary instrumentation such as filters, probes, and additional preamplifiers are shown in other figures.

Figure 58 Typical Instrumentation configuration

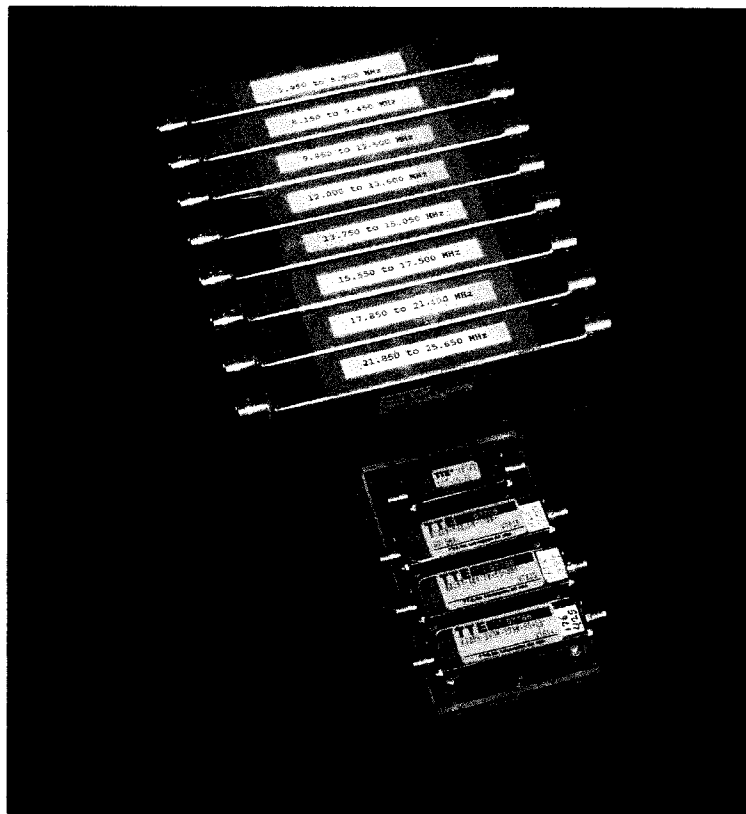
Figure 59 shows a photograph of two sets of filters often used to examine signals, noise and interference in the HF, VHF and the lower part of the UHF bands. The top set consists of a bank of eight filters covering portions of the HF band. This particular set shows band-pass filters covering portions of the HF spectrum between allocations for the International Broadcast Service. The bottom set shows four band-pass filters covering portions of the VHF and UHF bands. A number of additional single filters are used for special measurements.

**Figure 59** Example of Band-pass Filters

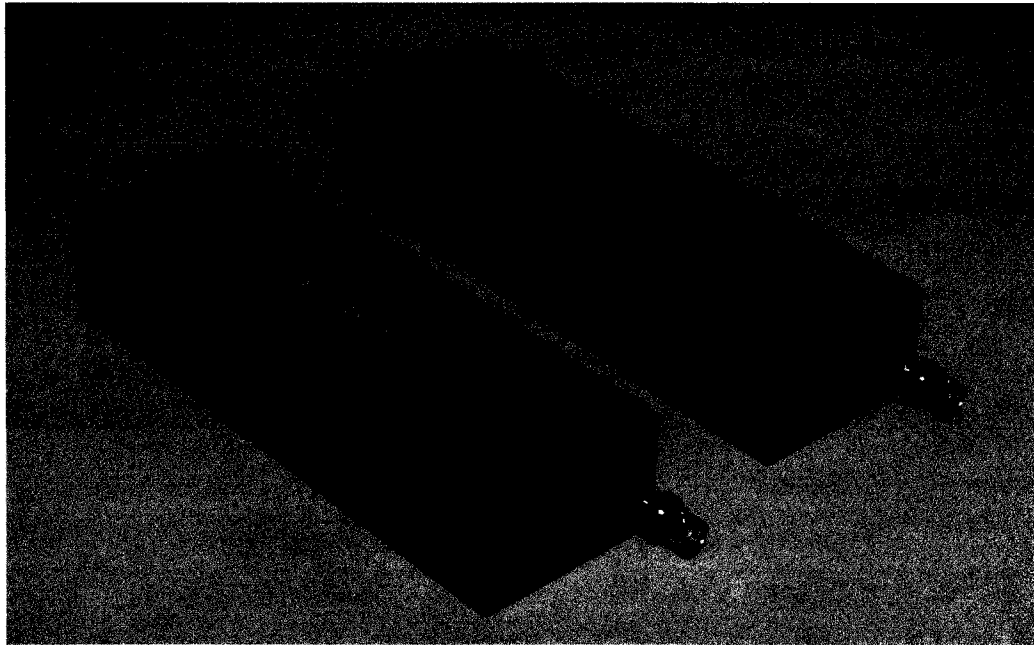
**Figure 60** Example of Special Purpose Filters for the UHF Band
